Rectory Lane Cemetery, Tree Survey

Report prepared by Dr Jeremy Biddle & Dr Astrid Biddle,
Dean Incent's House, 129 High Street, Berkhamsted, Herts, HP4 2DJ

Second issue, February 2017.

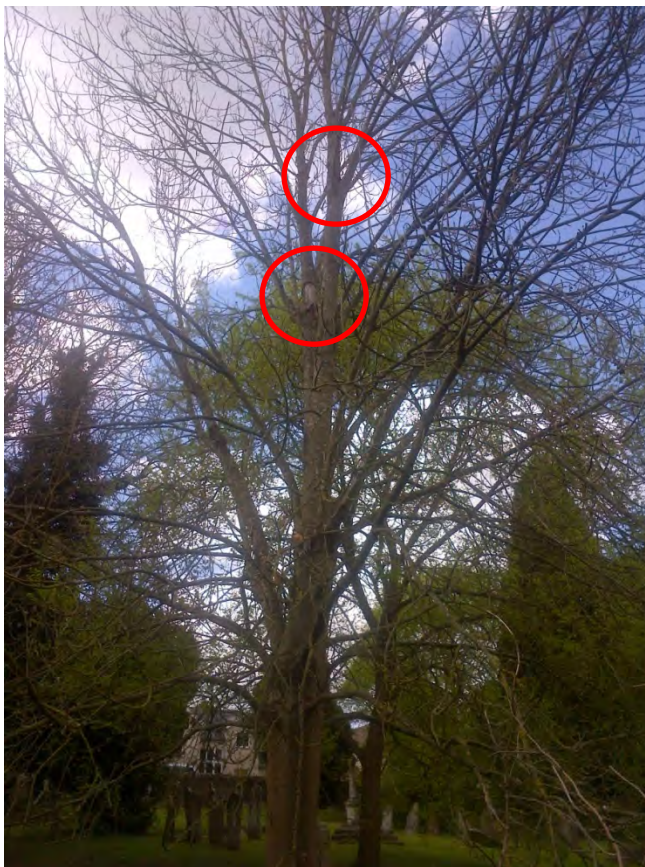
22 Ash

A large branch has recently fallen from this tree and further signs of squirrel damage are evident. In particular, the main leaders highlighted in the photograph show substantial damage and are in danger of falling.

Figure 2: Ash tree showing signs of squirrel damage (ringed)

This tree requires urgent attention.

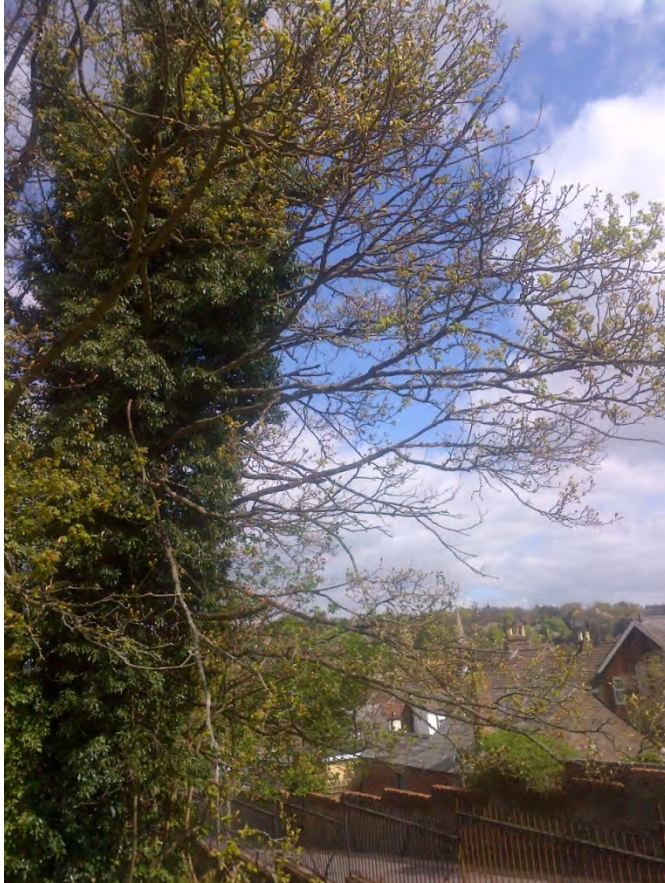
28 Sycamore

Large mature tree partially overhanging Three Close Lane, with a moderately heavy growth of ivy through the crown. There are signs of squirrel damage in several areas, though the extent of damage is difficult to assess due to the ivy. However, several large horizontal branches have died back and are in danger of falling; some of these overhang the footpath and highway on Three Close Lane and should be addressed urgently.

Figure 4: Sycamore adjacent to Three Close Lane

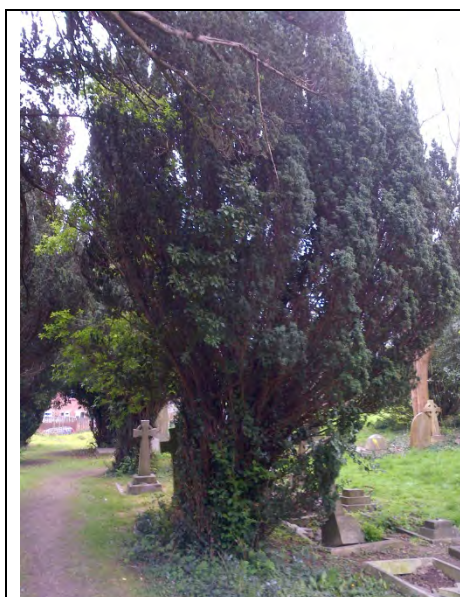
Part of the avenue of yews separating the lower and upper areas (no.9h). Note growth of ivy and elder within the canopies.

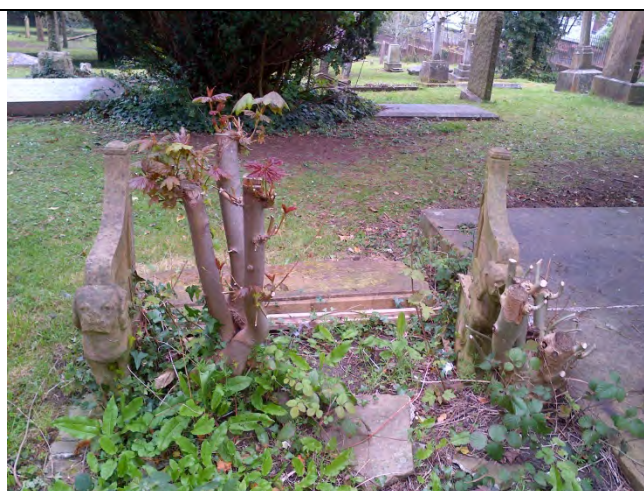
Sycamore saplings and re-sprouting stumps beneath the memorial bench (Lower area near no.9h)

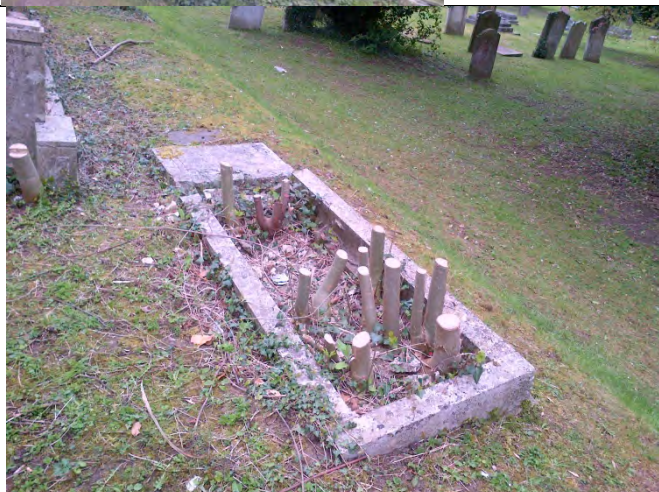
Sycamore and ash saplings and re-sprouting stumps within a grave near the yew avenue (Lower area near no.9k)

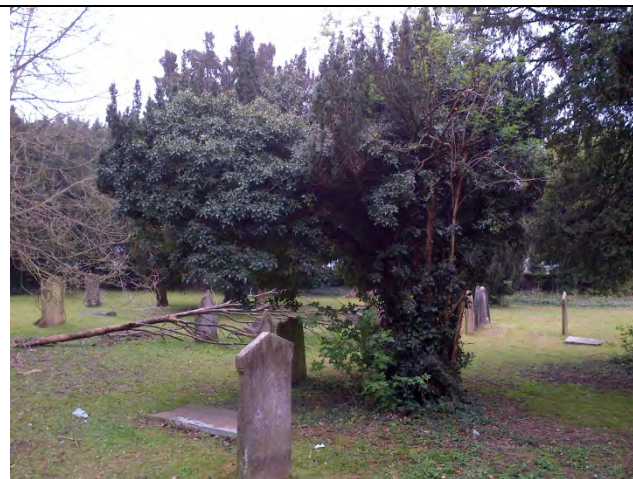
Yew trees heavily weighed down by ivy growing in the canopy (Lower area nos. 16 & 18). (Note also fallen bough in background from ash tree no.22)

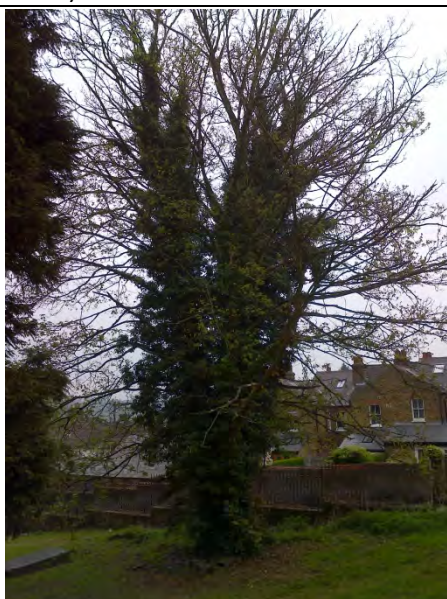
Large sycamore with several boughs showing sign of die-back and squirrel damage (Lower area no.28)

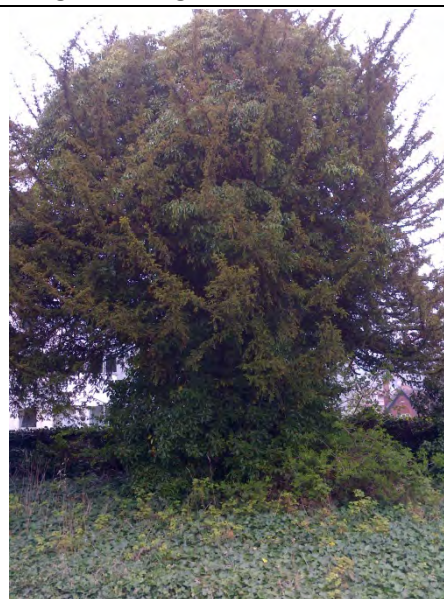
One of a row of large yew trees on the north-eastern boundary (Lower area no.1i)

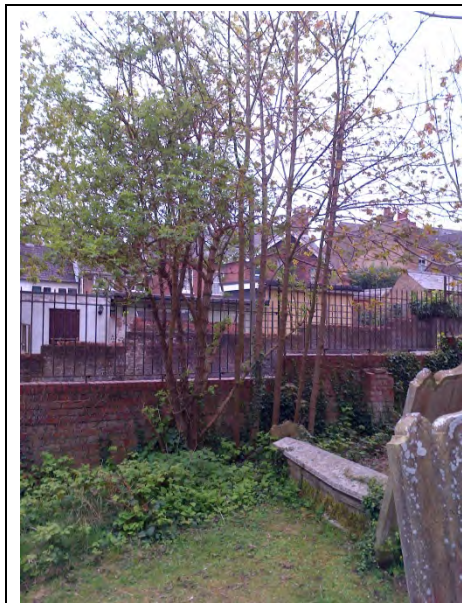
Examples of ash saplings near the boundary wall with Three Close Lane, felled in 2015. (Lower area near no.17)

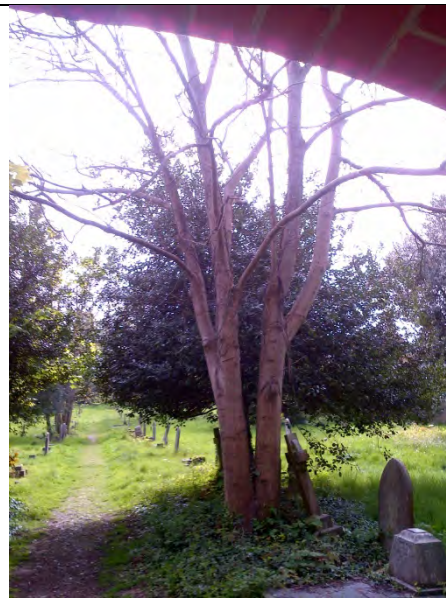
Multi-trunk ash tree near the arch at the entrance to the Upper area (no.2)

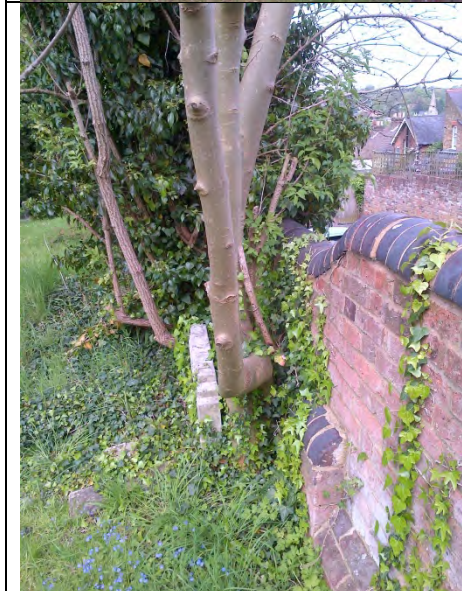
Ash saplings and elder tree growing adjacent to the boundary wall on Three Close Lane, felled in 2016 (Upper area no.4)

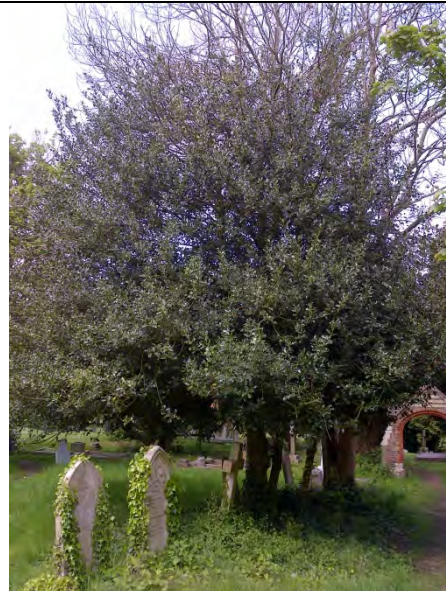
Holly and ash trees near the central footpath in the Upper area (nos. 2 and 6)

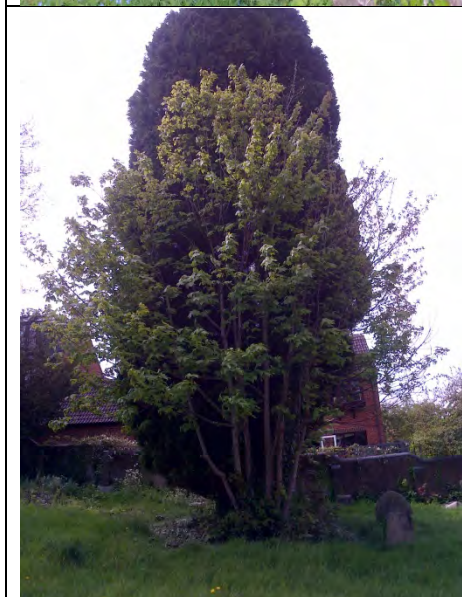
Cypress tree with a cluster of sycamore saplings (saplings felled in 2015) (Upper area no.16)

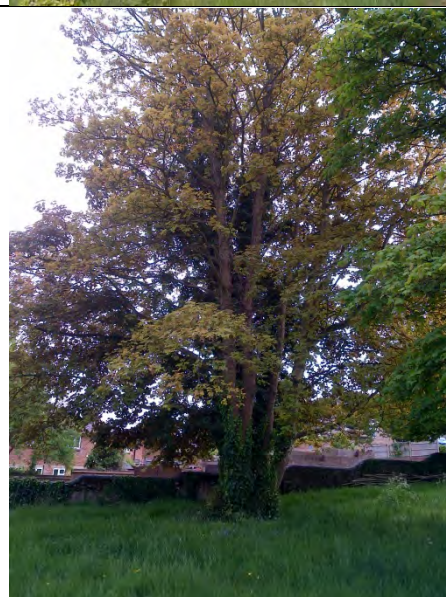
One of several large multi-trunk sycamore trees in the Upper area (no.13)

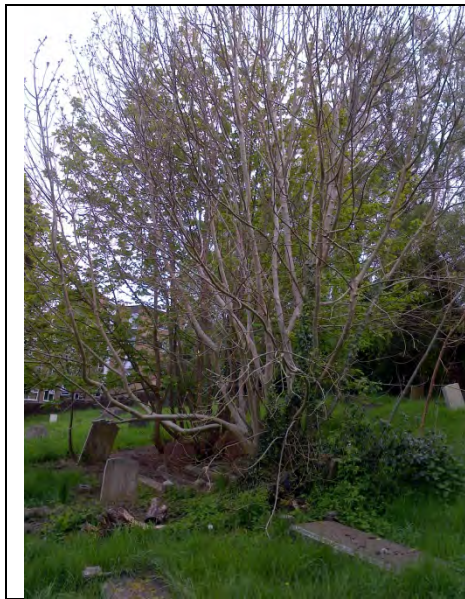
Sycamore re-growing from a stump, plus elder and cherry, all felled in 2016 (Upper area nos.37 & 38)

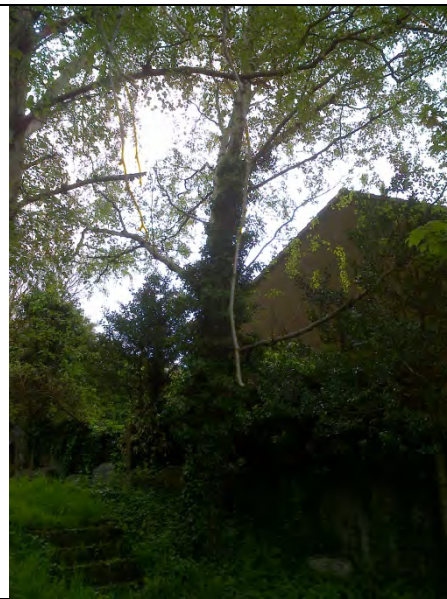
The western end of the row of silver birch near the top of the cemetery (Upper area no.42a)

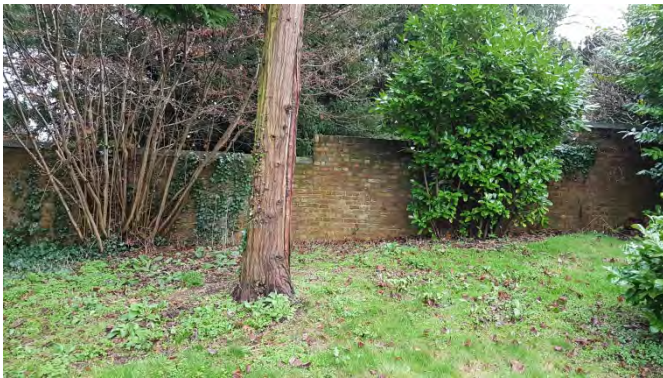
Hazel and cherry laurel trees growing close to the outside of the boundary wall in the Rectory Lane area, (Rectory Lane nos.15 and 17) with the trunk of Leyland cypress (no. 16) in the foreground.

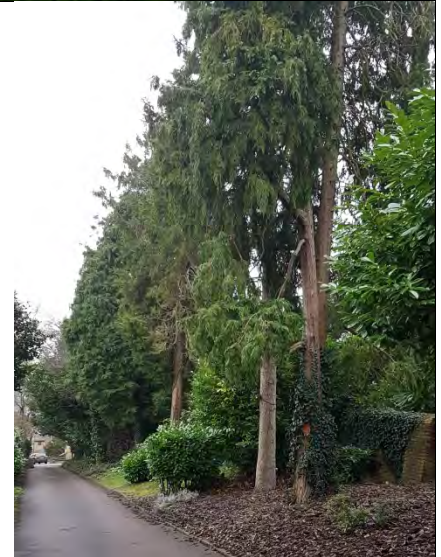
View north from the southern end of Rectory Lane. Leyland cypress (no.20) and Norway spruce (no.19) in the foreground.
