Rectory Lane Cemetery, Tree Survey

Report prepared by Dr Jeremy Biddle & Dr Astrid Biddle,
Dean Incent's House, 129 High Street, Berkhamsted, Herts, HP4 2DJ

Second issue, February 2017.

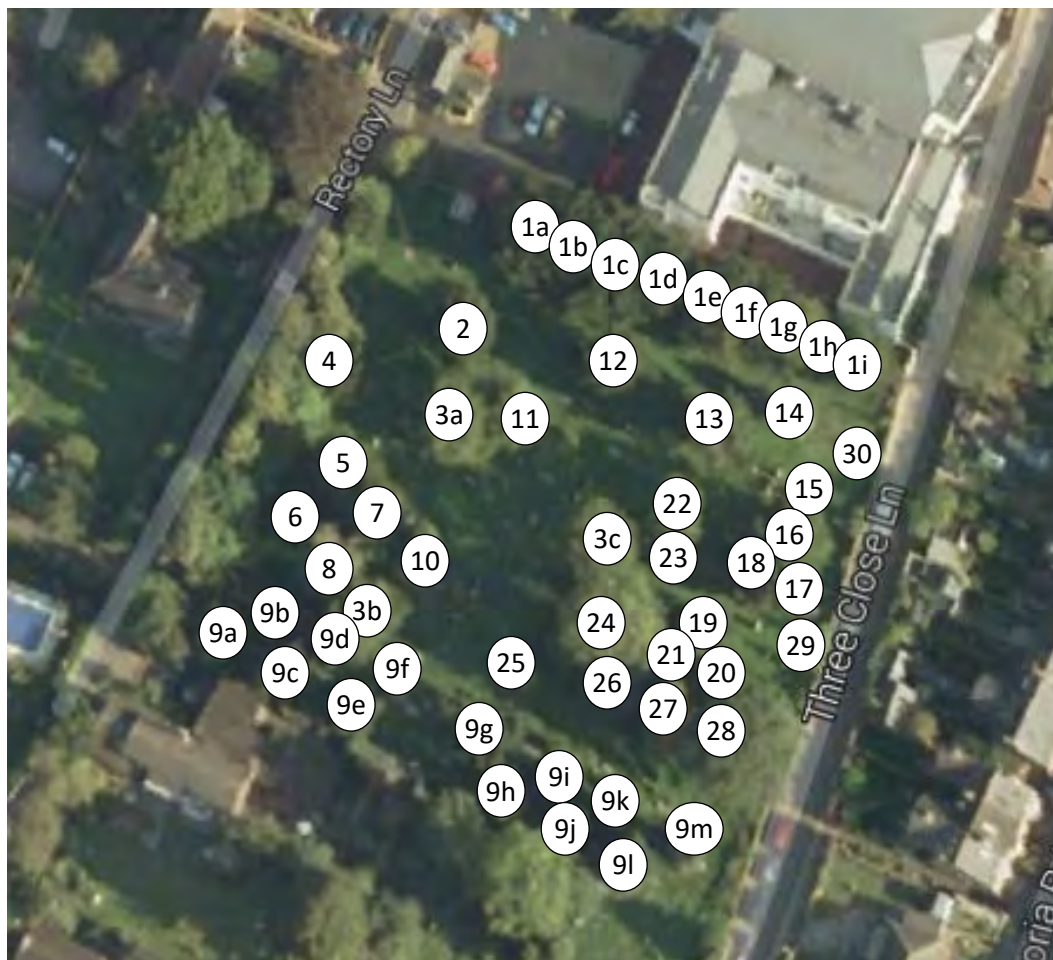
Numbers on the Key Plan refer to trees identified as below.

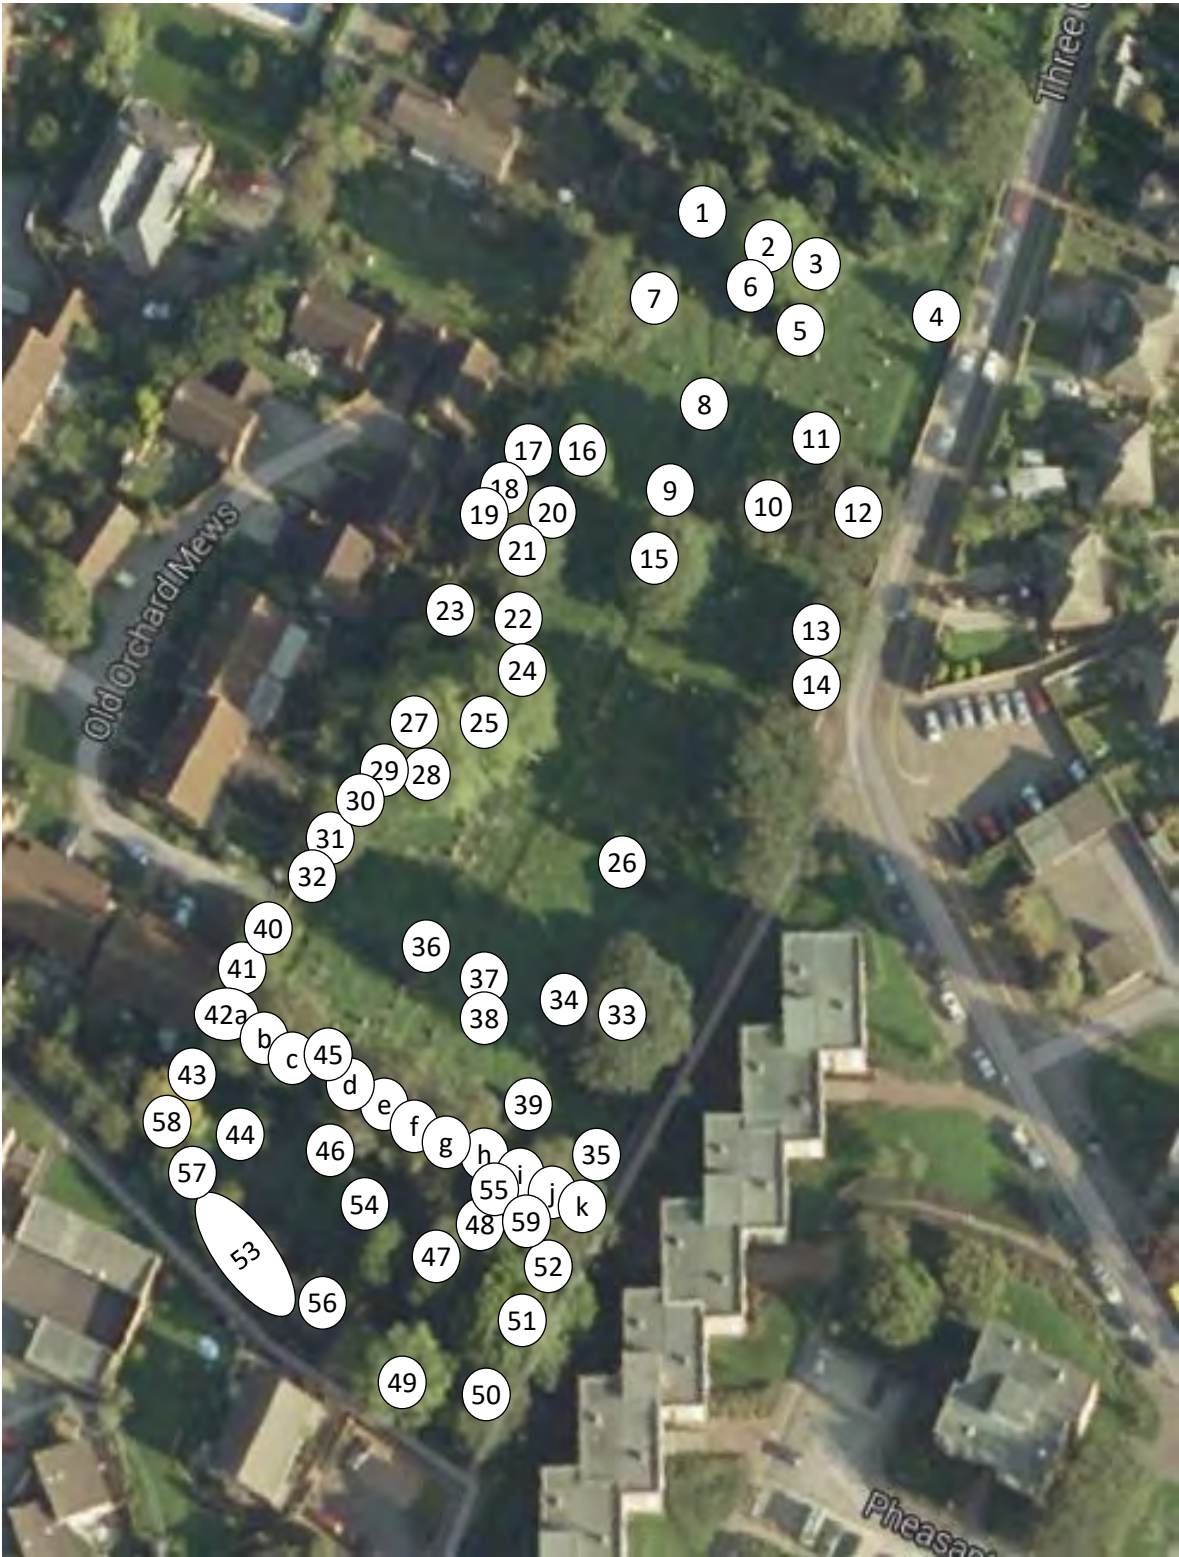
Key Plan

Further planting is proposed around the existing entrance onto Three Close Lane. The purpose is to provide screening of the flats and to replace the large sycamore tree shown on the aerial photo (next page) but felled in about 2010 (to the right of tree no. 26). Native species such as oak and beech are proposed.

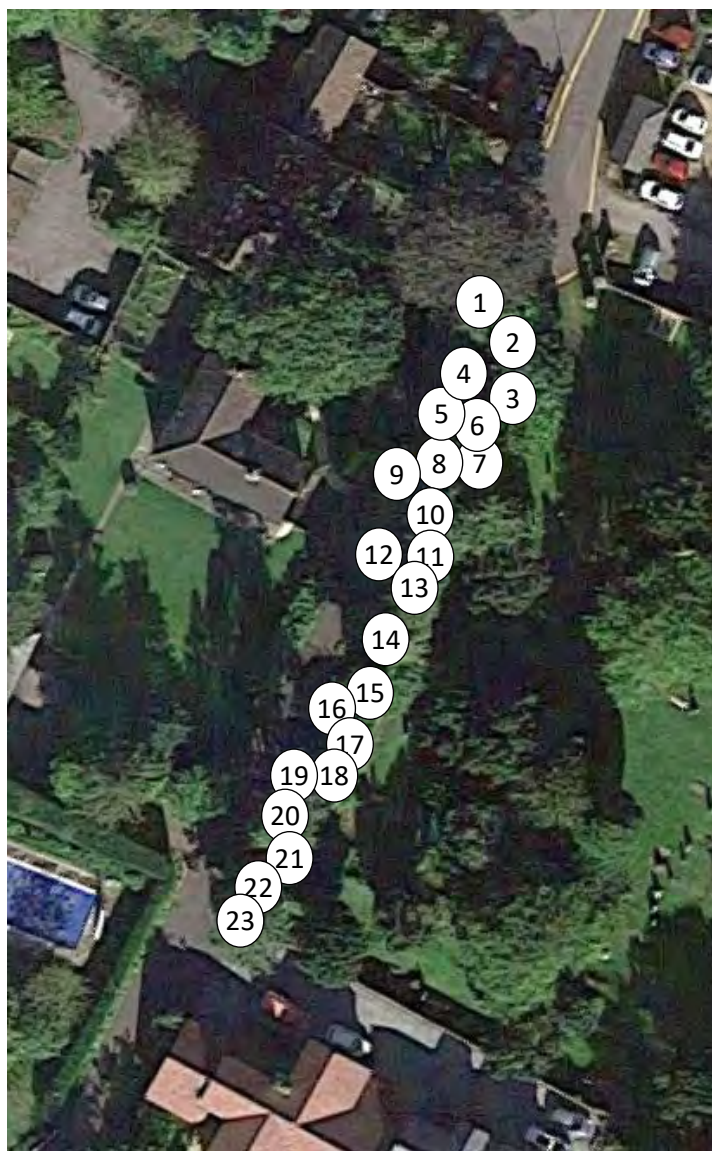
Key Plan

Several of the trees in this area are tall conifers, forming a landscape feature and a backdrop for views from the cemetery, though they do also create a rather shaded and enclosed atmosphere on Rectory Lane. Selected felling and clearance is recommended to enhance the landscape.
